How is this car doing?

G30

530e iPerformance · 2.0L B48 (B48B20M0)

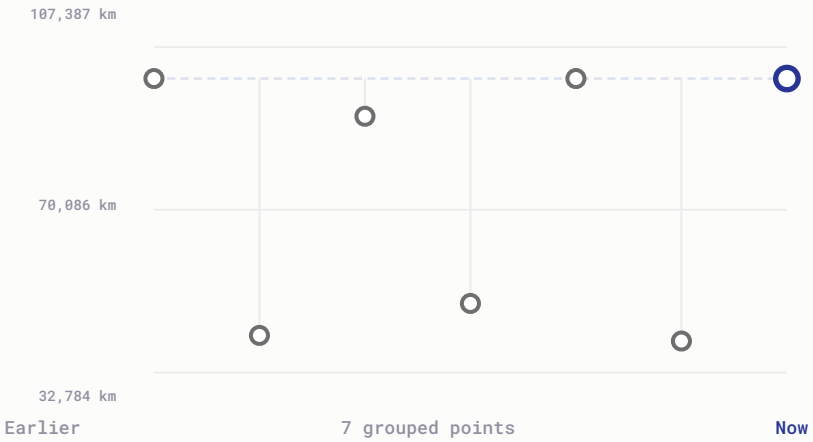
STORED MILEAGE HISTORY

Stored readings sit at or below the current mileage with no rollback pattern.
